HOBART'S FLOATING BRIDGE

Nomination for a Heritage Recognition Award

Prepared by Bruce Cole
for
Engineering Heritage Tasmania

Version 2
April 2014

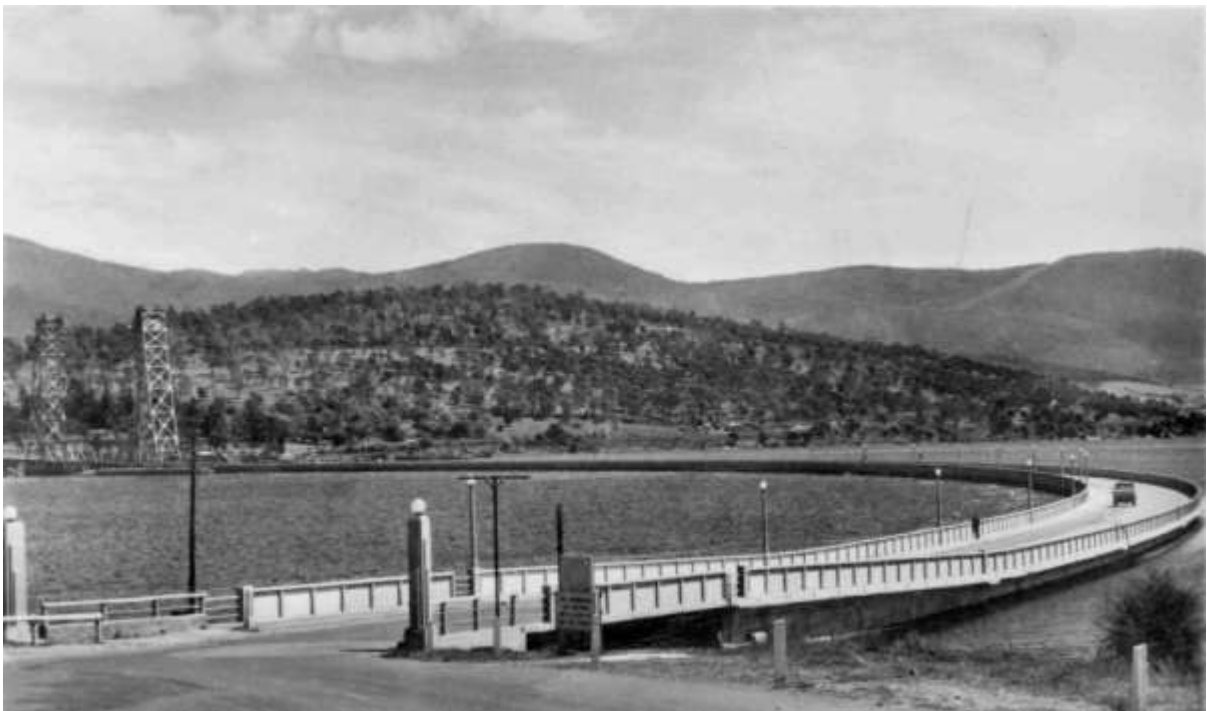
Bridge in service; lift span far left

The lift span for ship passage was suspended between two steel towers. The base of one tower formed the western abutment of the floating bridge. The eastern abutment was a small structure securely anchored to a circular trench cut into the rock on the shore. See cover photo.

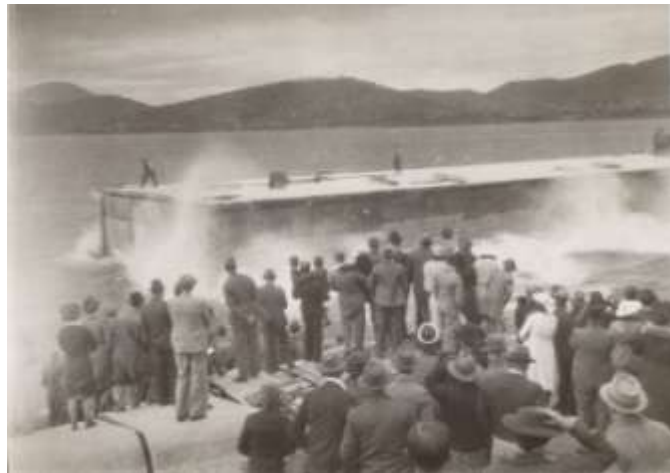
Figure 6: Launching a pontoon

On completion a pontoon was launched sideways down a timber slipway into the river. Each launch was a spectacular event which attracted public attention. See Figure 6. The first launch was a near disaster as the cradles stopped sliding short of floating level. Apparently the slipways had been greased too early and the crabs had eaten off the tallow. It was also found that the water was too shallow for the pontoon to float and all later launches were timed for mid-tide or above.

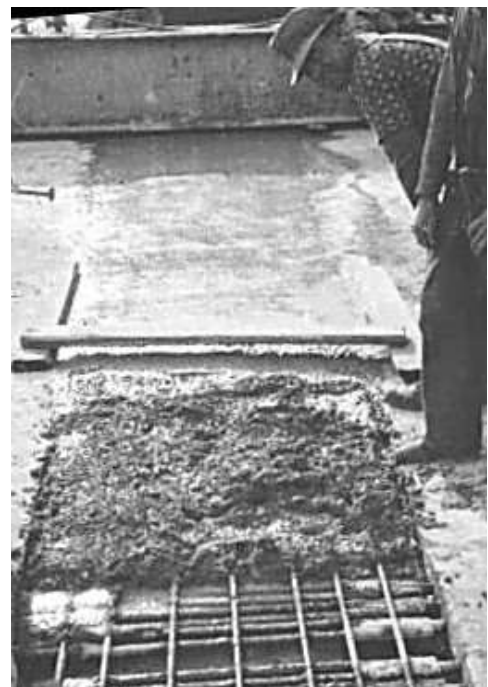
Figure 7: Joining two pontoons

The ends of the pontoons were designed for joining on the water. They featured steel reinforcement protruding from the concrete and a concrete lip of similar protrusion across the bottom and up both sides. When two pontoons were brought together, a strip of sponge rubber placed by divers between the lips was compressed and formed a watertight seal. The space between the temporary bulkheads was then pumped out so that the reinforcement could be welded and concrete placed in the dry.

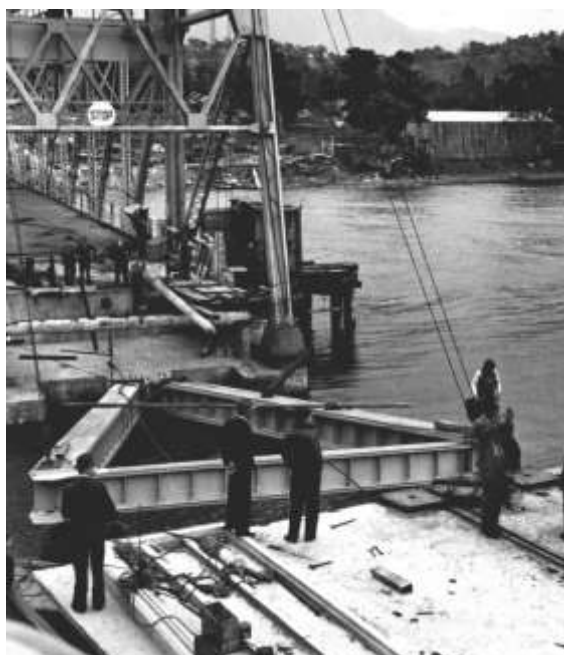
Figure 8: Hinged frames at abutments

The connections between the hinges and the steel frame were arranged so that heavy steel pins could be lowered through matching holes once the end pontoon was in exactly the right position. On completion the hinged frames were hidden under roadway on/off ramps.

Each hinge was bolted to the end pontoon with 50mm diameter steel bolts. Steel was difficult to obtain in wartime, and the contractor bought up all the 50mm rod that he could find. Some of the material was wrought iron and was rejected as unsuitable.

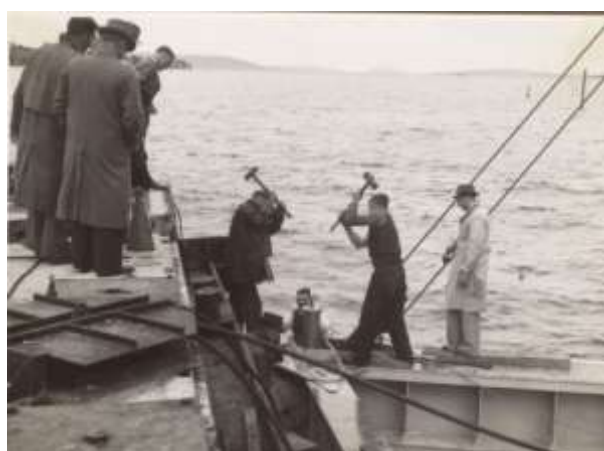
Figure 9: Driving pins at western connection

The next step was to tow the shore end of one arch in to the western abutment where, with the help of the ships and various winches, the connecting pins were

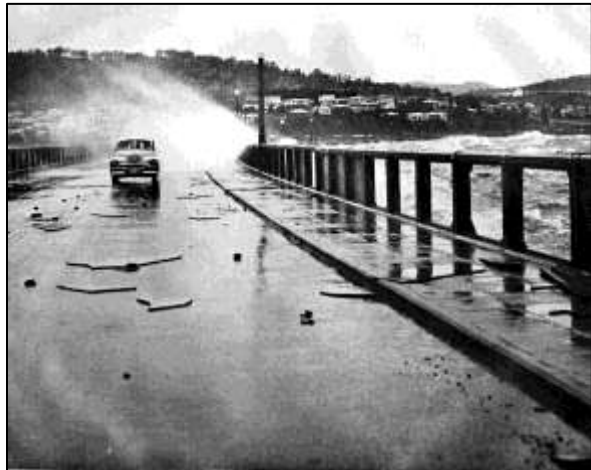
Figure 10: Storm in 1943

The bridge was virtually complete when, on 4th December 1943, a ferocious storm occurred. Large waves travelled up the river and thundered into the bridge. See Figure 10. Parapet panels along the roadway were smashed and undulations were observed along the roadway as the bridge rode the waves. Measuring devices on the hinged connections at each end showed rapidly oscillating tension and compression. At the western end, four of the ten bolts attaching one hinge to the pontoon snapped. See Figure 11.

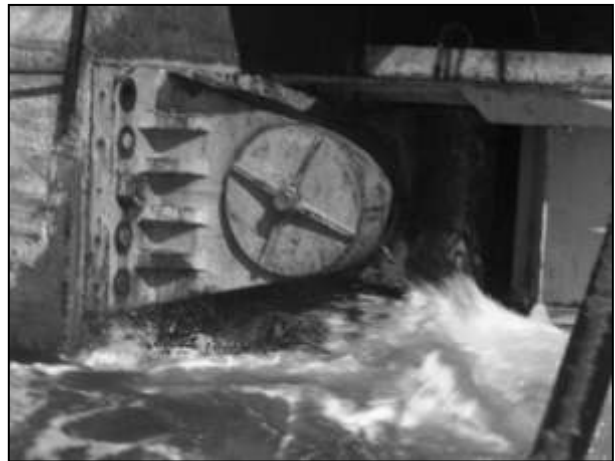
Figure 11: Hinge with broken bolts

During the storm the Director of Public Works George Balsille thought the bridge would be lost, but the remaining bolts held. Tests showed the broken bolts to be of wrought iron, mistakenly accepted when sorting the wrought iron from the mild steel rods.

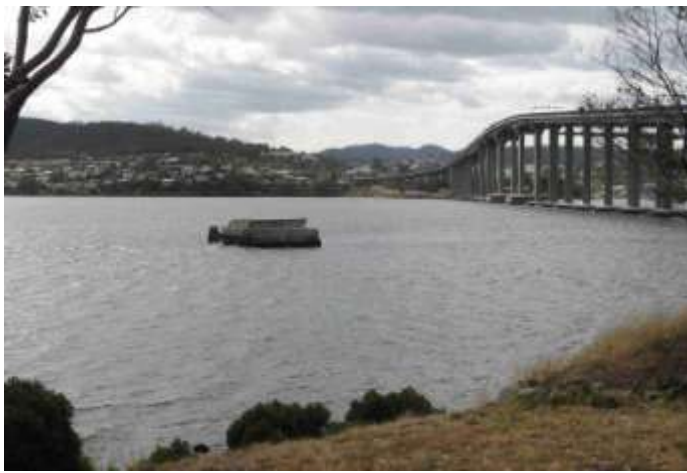
Figure 14: Remaining tower base

Today, only the eastern approach road remains, together with one concrete tower base still showing above river level and the 330mm diameter steel hinge pin, now on display outside the Royal Engineers Building in Hobart. See Figures 14 and 15.

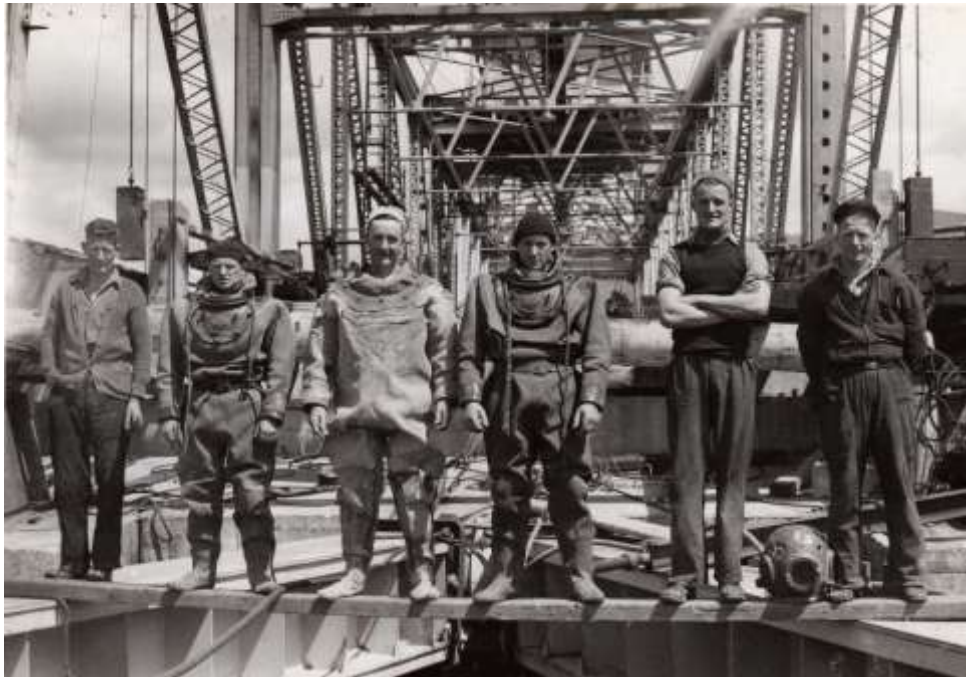
Figure A1: Divers and attendants

The foundations for the two towers were excavated inside circular steel caissons all the way down through the water, soft mud and cemented gravels to sound rock. Divers were required to inspect the rock and carry out surface clean up before the caissons were filled with concrete. Some of the divers suffered from the bends until the contractor fabricated an on-site decompression chamber.

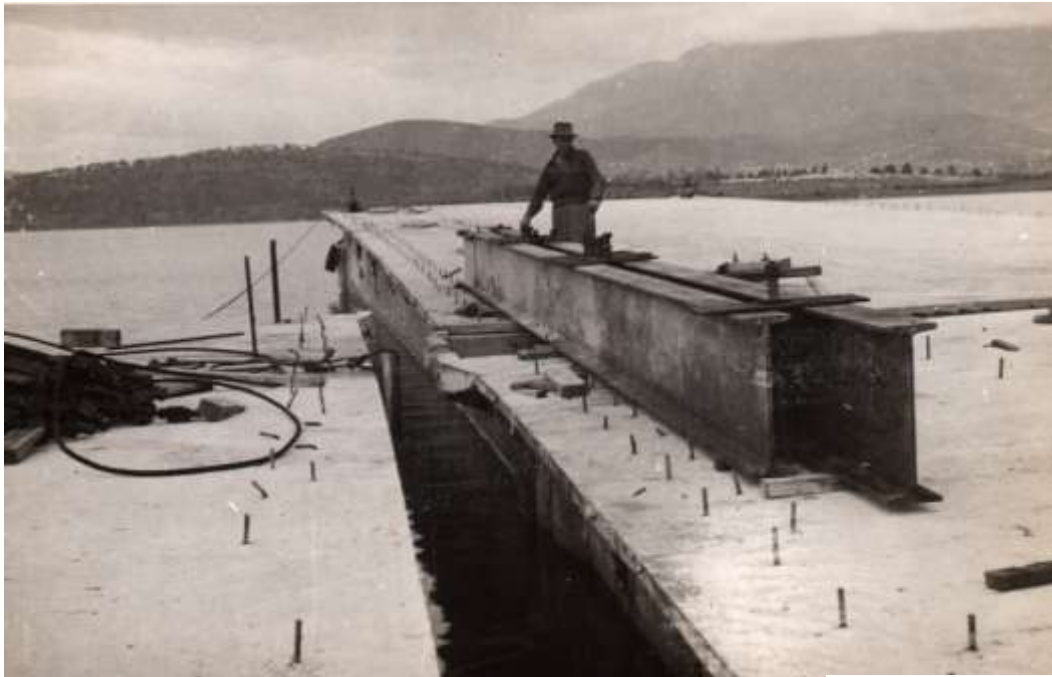
Figure A3: Keeping pontoons level with strongbacks before joining

But spare a thought for surveyor Charles Knight who had to ensure that the pontoons were accurately aligned and levelled when his survey instrument was standing on a floating base. Steel girders fixed across the join ensured that the pontoons matched at roadway level, and heaps of sand were shovelled to positions to achieve a level draft. At times the workmen had to stand still to avoid disturbing the level, however slightly. Most of the work was carried out at night to avoid differential temperature effects, and when two sections of four pontoons had to be joined, the curvature of the earth became appreciable.

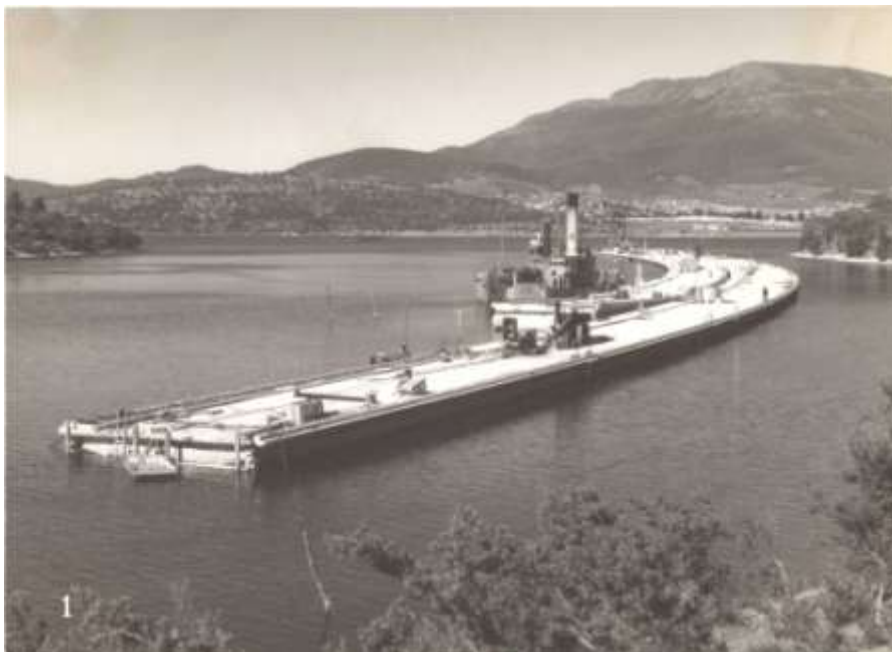
Figure A4: Two half arches in Geilston Bay, one ready for towing out.

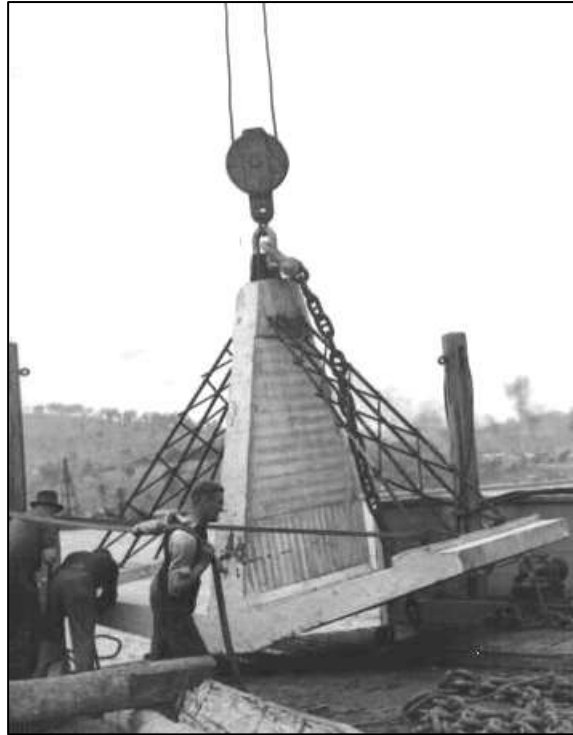
Figure A5: Mid-river anchor for bridge assembly

Installing the two curved segments across the river required considerable planning and coordination. In preparation for placing the two 480m long arches across the river, a large buoy was securely anchored at mid-river. Steam-driven donkey engines were fixed on the pontoon decks to drive winches. As no tugs were available, a motley flotilla of eight steam vessels was assembled: the vehicular ferry Lurgurena (which the bridge replaced), two Navy mine sweepers, four river steamers and a hopper barge. All the captains were carefully briefed and systems of communications and signals established.

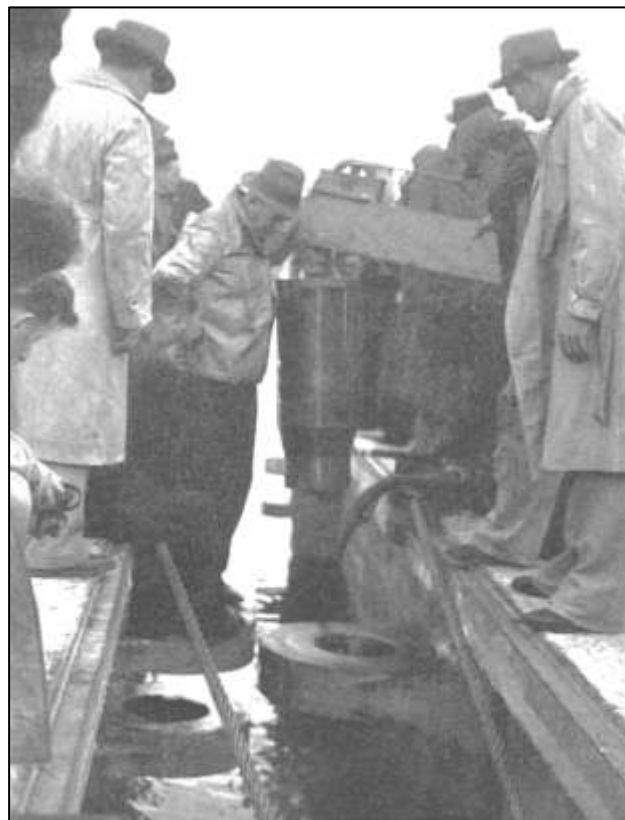
Figure A8: The pin ready to join the two half arches

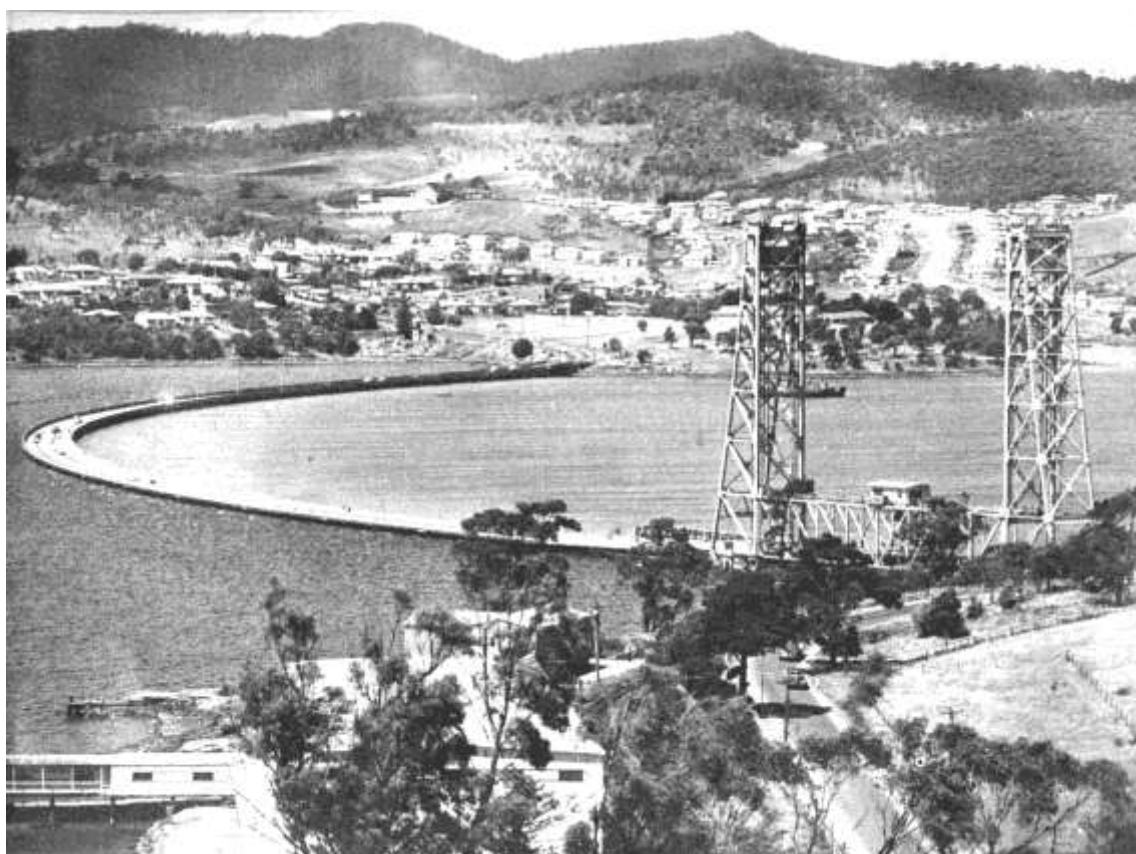
Figure A10: Many houses on eastern shore

Its replacement was the four lane Tasman Bridge immediately downstream, a multi-span high level structure under which ships could pass without disrupting the traffic flow. See Figure A10 in Appendix A.

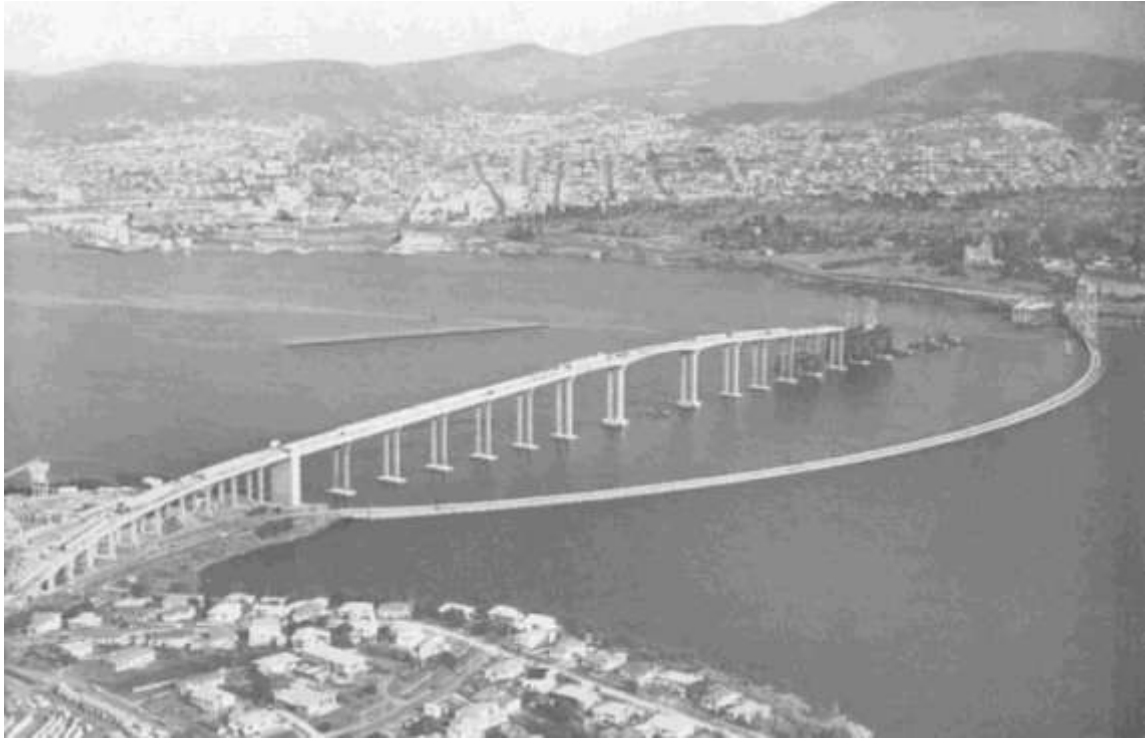
Figure A11: Tasman Bridge nearing completion

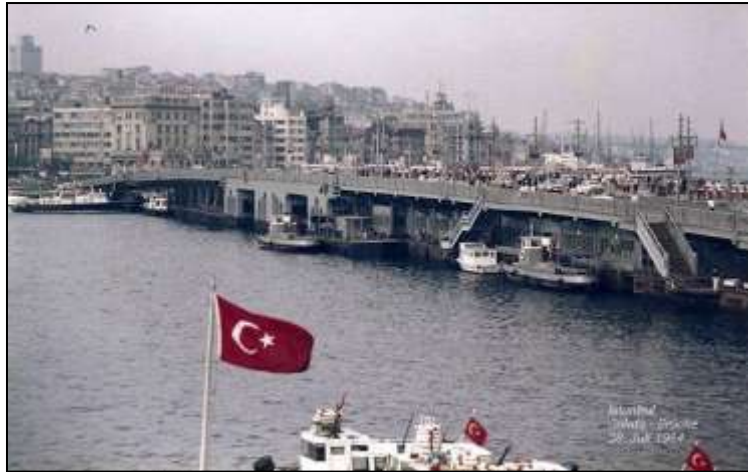
Galata Bridge, Istanbul in 1984

One is the Galata Floating Bridge (No. 1) in Istanbul, built in 1912 with steel pontoons. The photo below shows it to be a straight double-decker bridge with six traffic lanes on top and continuous shops below. It was damaged by fire and towed away in 1992 to make way for a replacement.

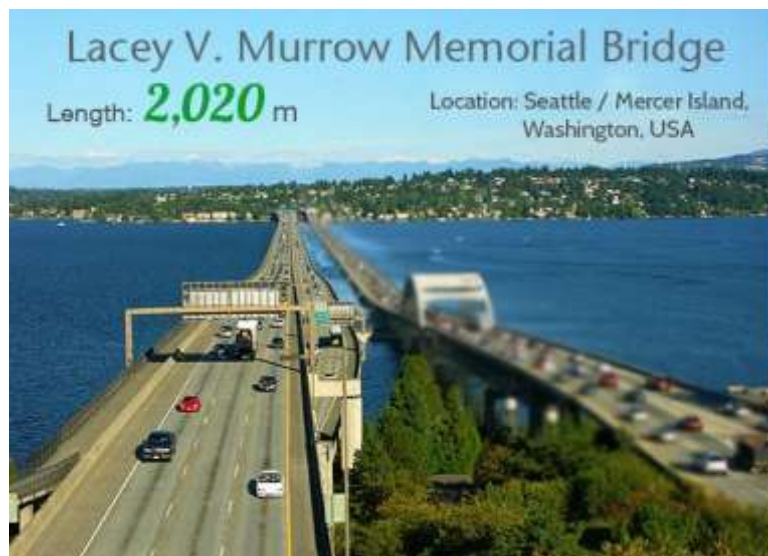
Lacey V Murrow Bridge on the right

The other is the Lacey V Murrow Bridge (No.2) in Washington State, USA built in 1940. The photo in the report shows it was a straight bridge. (It was damaged during modifications and sank in 1990. It was being replaced in 2010, traffic being carried on a parallel floating bridge built in 1989.)

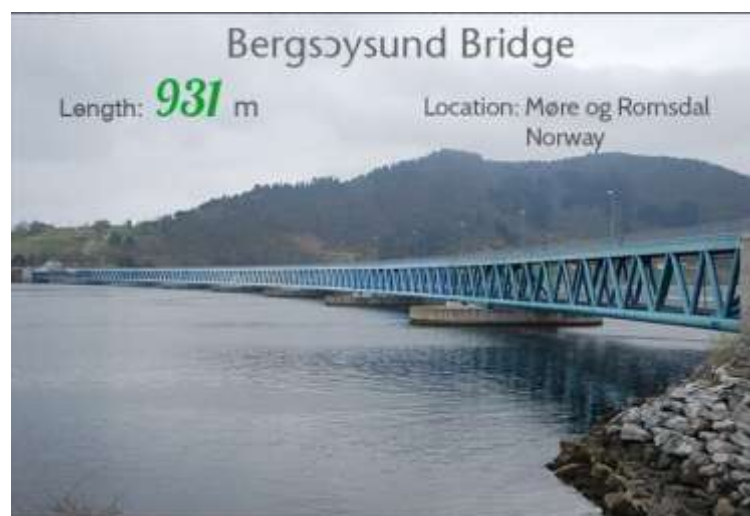
Begsoysund Bridge

The Nordhordland Bridge (No.10) built in 1994 is similar. The curved superstructure is continuous concrete box girder which also forms the bridge deck. See photo below.

The water depth of 300m and 500m for these two bridges put midstream anchors out of contention.
